Pulse Oxidation System at GEA Farm Technologies Warminster Chemical Production Facility

EXECUTIVE SUMMARY

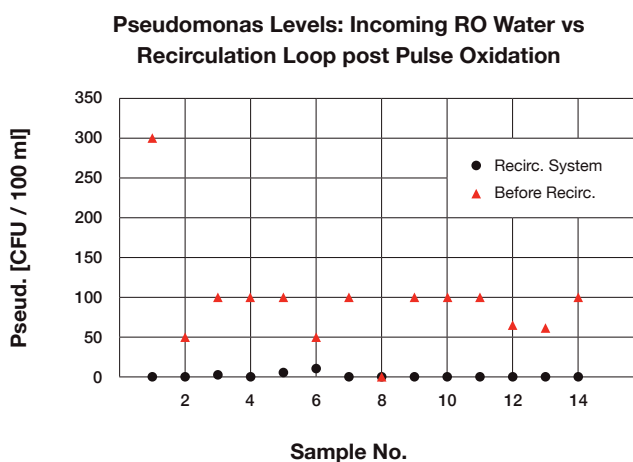
Figure 2:

As shown in **Table 1** and **Figure 2**, the Pulse Oxidation system consistently reduced *Pseudomonas* levels within the recirculation loop to near or non-detectable levels following the system clean.

Despite incoming RO water containing counts exceeding 100 CFU per 100 ml, the recirculation system maintained mean levels of just 1.21 CFU per 100 ml, representing an average reduction of over 98%. The geometric mean reduction also exceeded 98%, confirming the system's ongoing ability to suppress biofilm regrowth and maintain water quality suitable for chemical production and other high purity industrial applications.

Pseudomonas Levels: Incoming RO Water vs Recirculation Loop post Pulse Oxidation				
Date	Sample No.	Recirc. System	Before Recirc.	% Reduction
15 Oct 25	1	0	>300	>99.6%
29 Oct 25	2	0	50	>98%
30 Oct 25	3	1	>100	>99%
01 Nov 25	4	0	>100	>99%
06 Nov 25	5	5	>100	>95%
11 Nov 25	6	10	49	79.6%
14 Nov 25	7	1	>100	>99%
20 Nov 25	8	0	0	N/A
26 Nov 25	9	0	>100	>99%
06 Dec 25	10	0	>100	>99%
11 Dec 25	11	0	>100	>99%
19 Dec 25	12	0	65	>98.4%
23 Dec 25	13	0	61	>98.3%
07 Jan 26	14	0	>100	>99%
Mean		1.21	>94.6	>98.7%
Geometric mean: GM($x x = 0 \rightarrow 0.5$)		<0.81	>62.7	>98.7%

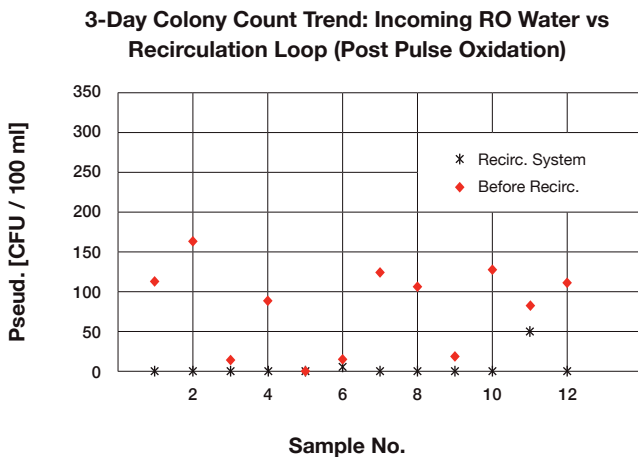
Figure 3:

As shown in **Table 2** and **Figure 2**, the Pulse Oxidation system effectively controlled microbial regrowth over a 3-day incubation period within the recirculation loop. Even when incoming RO water contained colony counts up to 163 CFU per ml, levels within the recirculation system were consistently reduced to near or non-detectable levels. The mean reduction across all samples was 94.1%, with a geometric mean reduction exceeding 98%, demonstrating the system’s ability to prevent biofilm reestablishment and maintain water quality suitable for high purity process applications.

3-day colony count [CFU / ml]				
Date	Sample No.	Recirc. System	Before Recirc.	% Reduction
30 Oct 25	1	0	114	>99.1%
01 Nov 25	2	0	163	>99.3%
06 Nov 25	3	0	14	>92.8%
11 Nov 25	4	0	89	>98.8%
14 Nov 25	5	1	1	0.0%
20 Nov 25	6	5	16	68.8%
26 Nov 25	7	0	123	>99.1%
06 Dec 25	8	0	106	>99.0%
11 Dec 25	9	0	18	>94.4%
19 Dec 25	10	0	124	>99.1%
23 Dec 25	11	51	84	39.3%
07 Jan 26	12	0	112	>99.1%
Mean		4.75	80.3	94.1%
Geometric mean: GM($x x = 0 \rightarrow 0.5$)		<0.94	46.5	>98.0%
